Airworthiness Bulletin

AWB 27-001 Issue 8 – 19 October 2021

Control Cable Terminal - Inspection and Replacement

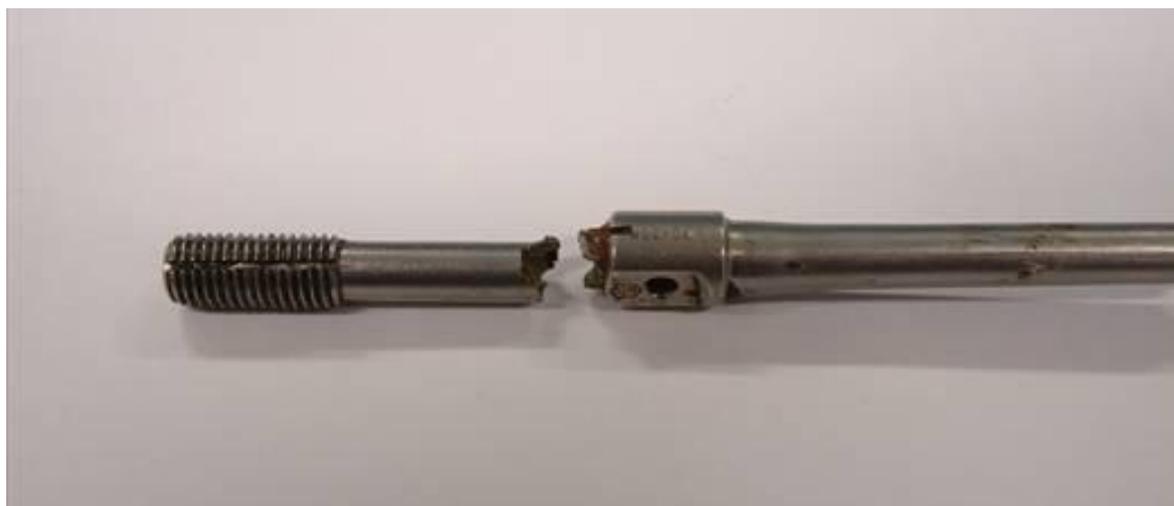
Investigations have revealed that the failed terminals had been in service for approximately 15 years or more and were typically identified by standard terminal fitting part numbers AN669, MS21260 and NAS650.

Figure 1 - Flight control cable terminal separation

Terminal fitting separation as described in this AWB is due to chloride stress-corrosion cracking (CSCC) a form of intergranular cracking which does not provide clear visual clues to the full extent of the internal structural damage and can originate from within the terminal (See Figure 7).

- b. Retire all flight control cable assemblies with terminals made from stainless steel (SAE-AISI 303Se and SAE-AISI 304) including, but not limited to, terminals manufactured to MS20658 (AN658), MS20667 (AN667), MS20668 (AN668), MS21259 (AN666) and MS21260 (AN669 or NAS650), before reaching 15 years total time in service.

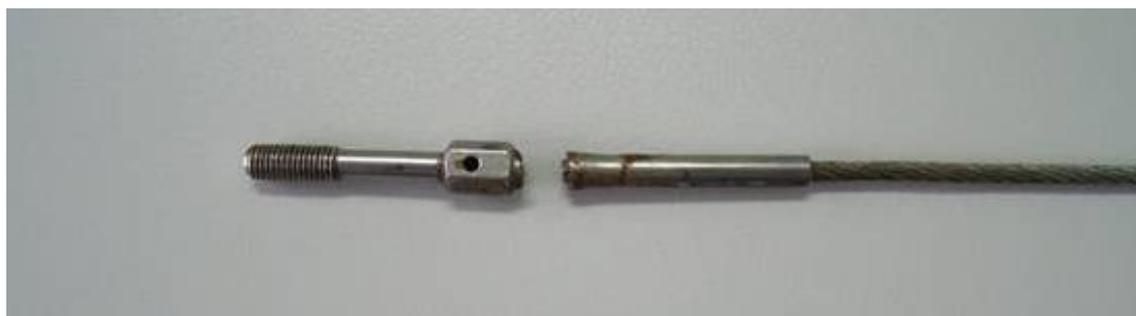
Figure 2 - Flight control cable terminal separation.

Note that the failure has occurred outside the safety lockwire hole.

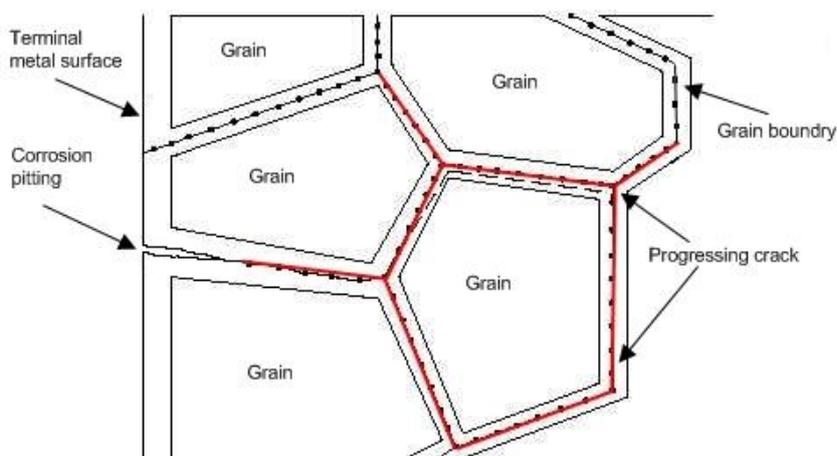
Figure 3 - Intergranular Corrosion Cracking

The sketch above (Figure 3) shows small surface pitting can be evidence of advanced intergranular corrosion. Rusty stain deposits, when removed usually reveal areas of small pitting.

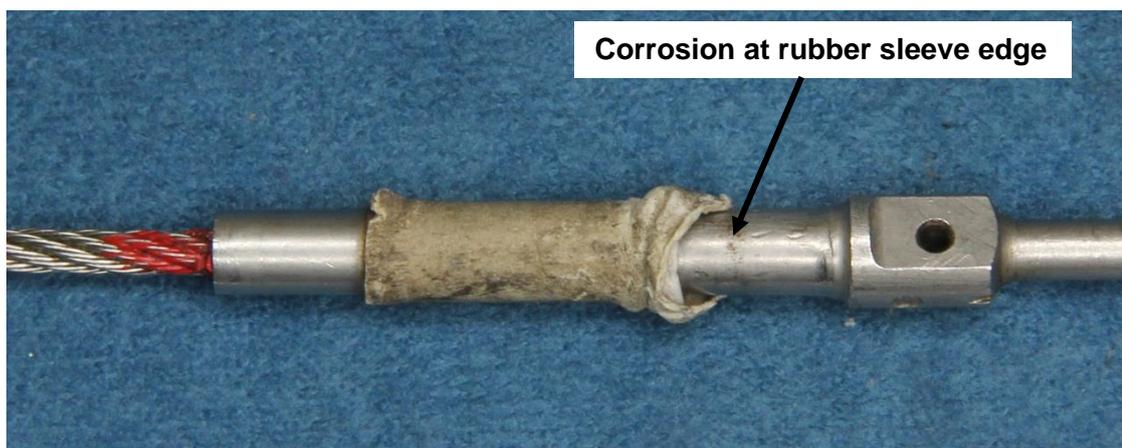
Corrosion pitting has been found under the rubber sleeves and tape wrapped around the terminal to provide part number identification. During an inspection corrosion was detected at the edge of a rubber sleeve, as shown in Figures 4 and 5, below. When the sleeve was pulled back, the maintainer found severe corrosion under the rubber sleeve. A total of four flap control cable terminals were corroded in one aircraft. These flap control terminals had been in service for approximately 13 years.

Figure 4 - Control cable terminal section covered in rubber sleeve
(Source ATSB Investigation AE-2012-028 Final - 9 April 2013).

- a. Visually inspect control cable terminals, irrespective of the total time in service, for the presence of any rubber sleeves, tape or any other material/substance (other than lockwire) that may prevent the chromic oxide film from forming. Such material should be removed and the terminal inspected for corrosion, particularly in the area that was covered by the rubber sleeve or tape. Any sign of corrosion is cause for rejection.

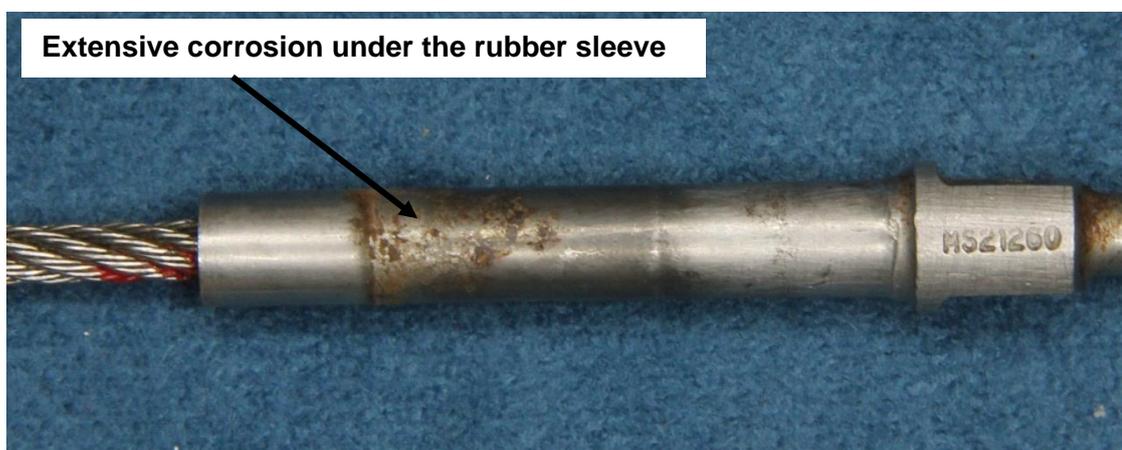
Figure 5 - Control cable terminal shown in figure 5, with the rubber sleeve removed. Note extensive corrosion. (Source: ATSB Investigation AE-2012-028 Final – 9 April 2013).

Stainless steel's resistance to corrosion is primarily attributed to the existence of a thin chromic oxide film which develops in the presence of oxygen in the atmosphere. Stainless steel must be in continual contact with oxygen in order to develop and maintain the integrity of the film. A breakdown in an area of the oxide film due to lack of oxygen can allow localised corrosion cells to form. The presence of the rubber sleeves or tape over the terminals prevented the chromic oxide film to form, allowing corrosion to develop.

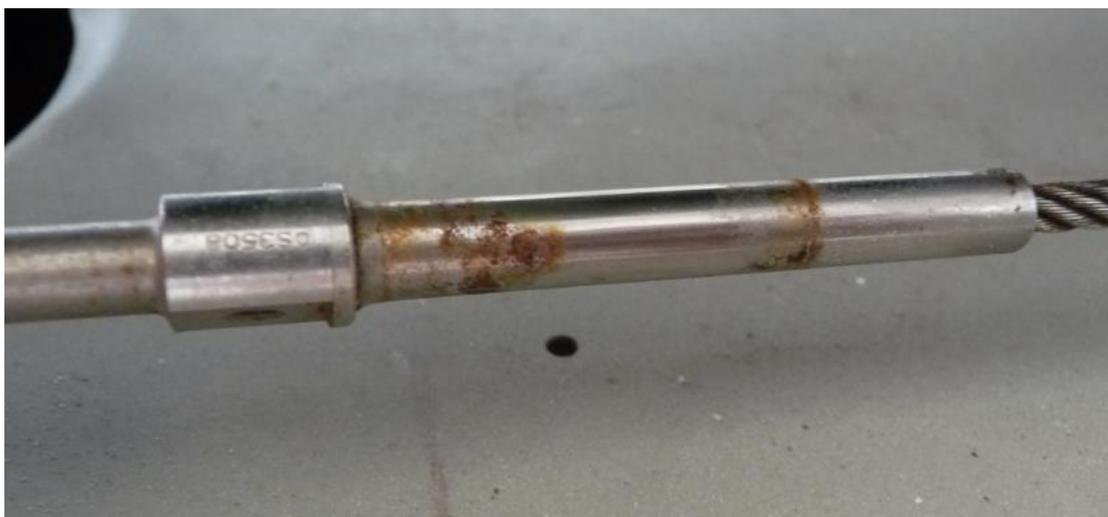
The corrosion on a rudder cable terminal in Figure 6 was also discovered under rubber tubing sleeve installed by the manufacturer. No less than eleven (11) cases of control cable terminal corrosion were discovered on the one aircraft. The cables had been in service for less than 10 years.

Figure 6. Source: CASA SDR. One of the eleven corroded primary flight control cables on the single aircraft. Corrosion originated from under the rubber sleeve.

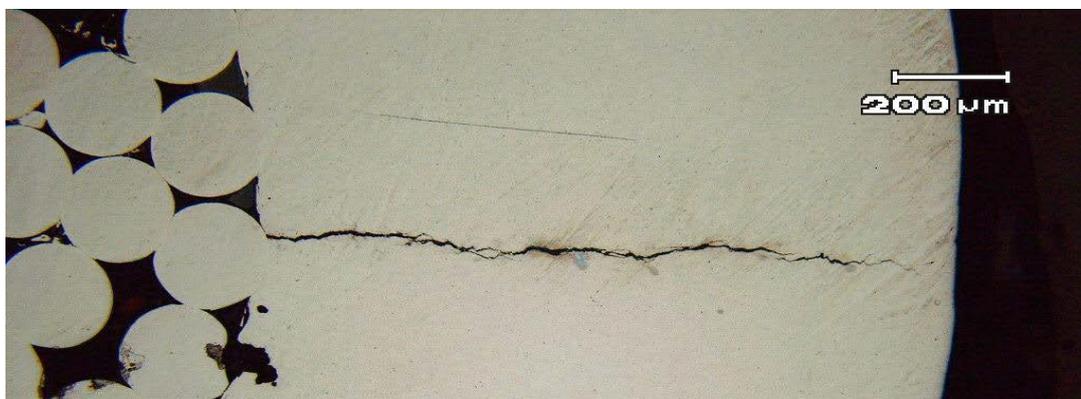
A formal investigation by the New Zealand Civil Aviation Authority into a report of stainless steel control cable terminal corrosion, discovered evidence of CSCC originating from the inside of the terminal. Since such cracking can originate from within the terminal, external surface clues such as pitting or cracking may not provide an adequate basis for determining serviceability. This introduces the possibility that a terminal may be close to failure and may even fail with little or no surface indication.

Figure 7 - Internal corrosion - flight control terminal sleeve.

The crack shown in Figure 7 originates from the cable wires (on the left of the picture) swaged in the terminal sleeve. The corrosion has not yet reached the outside surface of the terminal sleeve.
