[Docket No. FAA-2010-1101; Directorate Identifier 2009-CE-013-AD; Amendment 39-16690; AD 2011-10-09]

Airworthiness Directives; Cessna Aircraft Company Models 150, 152, 170, 172, 175, 177, 180, 182, 185, 188, 190, 195, 206, 207, 210, T303, 336, and 337 Airplanes

ACTION: Final rule.

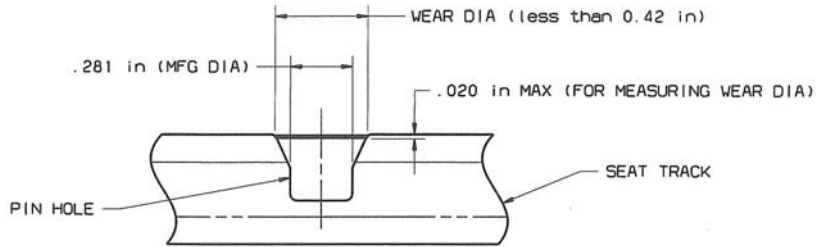
Figure 1. Diameter of seat pin locking engagement hole

Dave McFarlane requested we add a maximum allowable incremental 0.07-inch radius dimension to figure 1 at the outside diameter dimensions for clarification.

We disagree with this comment. The measurement dimensions in figure 1 adequately address the measurements necessary for this AD. Additional measurements will not provide any additional benefit.

(3) Inspect the diameter of each seat locking pin engagement hole in the pilot and copilot seat rails for excessive wear. Due to wear on the rail surface at the hole opening, we allow this measurement 0.020 of an inch below the surface of the rail. You must take this measurement somewhere between the surface of the rail or no more than 0.020 of an inch below the surface of the rail.

(i) If the diameter of any of the holes is 0.42 of an inch or more (see figure 1), before further flight, replace the rail.

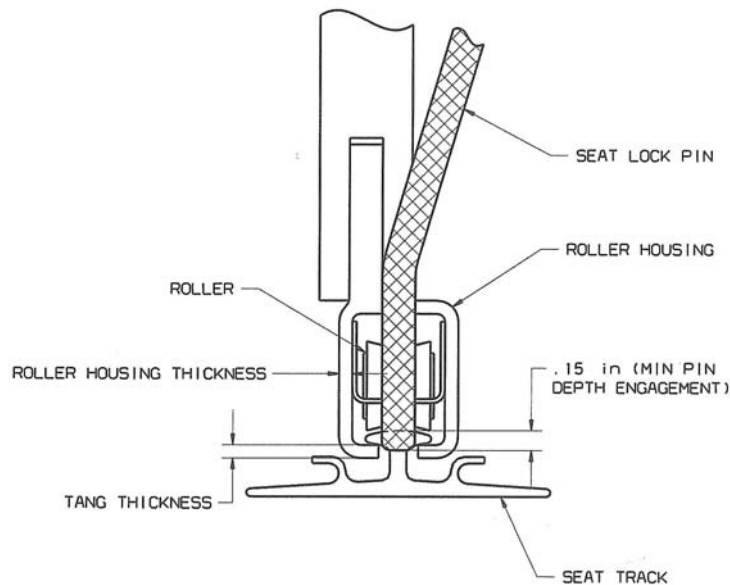
Figure 2. Seat locking pin depth engagement

(10) Lift up the forward edge of each seat to eliminate vertical play of the seat locking pin in the engagement hole, and from this position, inspect the depth of engagement of each seat locking pin (see figure 2). If the rail is worn, this depth is measured from the worn surface, not the manufactured surface.

(i) If engagement of any of the seat locking pins measures less than 0.15 of an inch, before further flight, replace or repair any seat components necessary to achieve a seat pin engagement of a minimum of 0.15 of an inch.

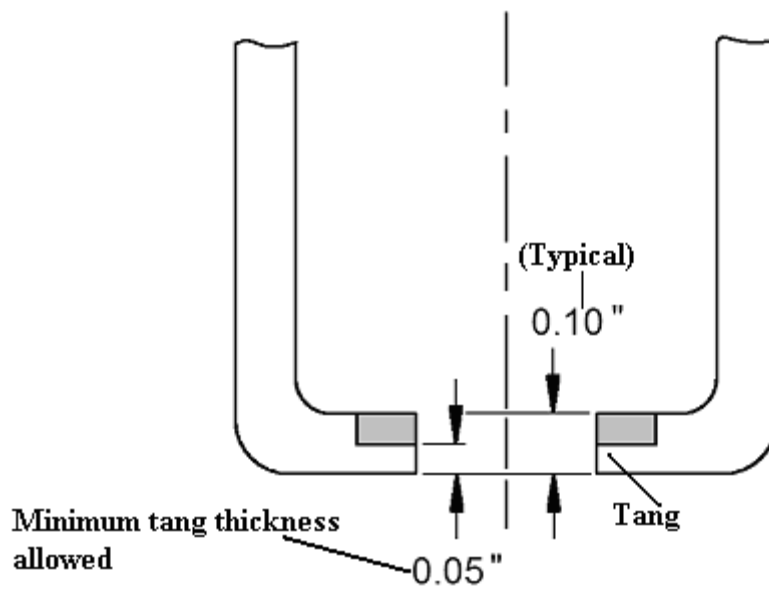
Figure 3. Closeup of seat roller housing and tang thickness

(5) Inspect the thickness of the tang (see figure 2 and figure 3). Due to wear of the tang chafing against the seat rail, measure the tang thickness where the tang inner edges contact the seat rail.

(i) If the tang thickness measures less than 0.05 of an inch, before further flight replace the roller housing.

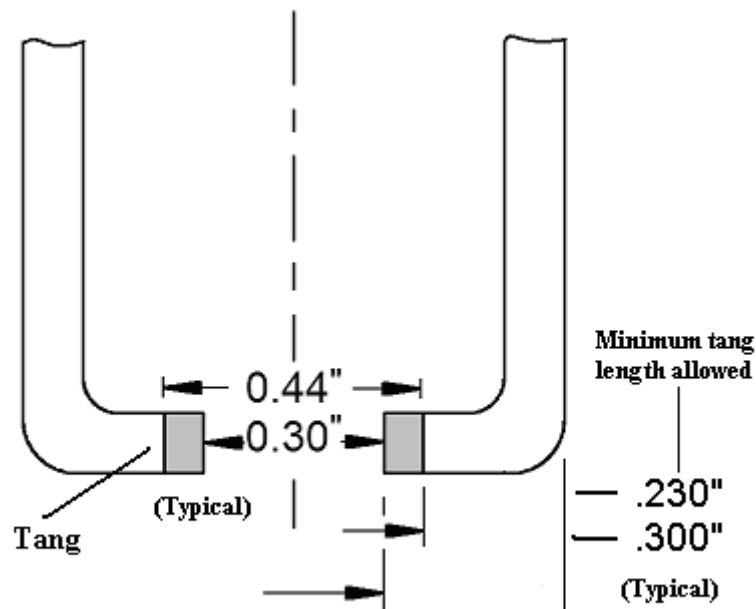
Figure 4. Closeup of seat roller housing and tang gap width

We agree with this comment. We agree that measuring the tang length inside of the roller housing is difficult because of the presence of the rollers inside of the roller housing.

(6) Due to wear or deformation of the tangs, inspect the tang length from the inner edge of the tang to the outer edge (the bend area) of the roller housing (see figure 4).

We have changed the callouts in figure 4 to measure the tang length from outside of the roller housing instead of from inside of the roller housing. We have also changed the description of the tang measurement in figure 4 to more accurately describe the measurement.

(i) The minimum measurement allowed for the remaining tang length is 0.230 inches remaining on either of the tangs, from the inner edge of the tang to the outer edge (the bend area) of the roller housing. If the measurement is less than 0.230 inches on either of the tangs, before further flight, replace the roller housing.
