SERVICE BULLETIN

NO. 1245A

Date: November 28, 2012

SUBJECT: STABILATOR CONTROL SYSTEM INSPECTION

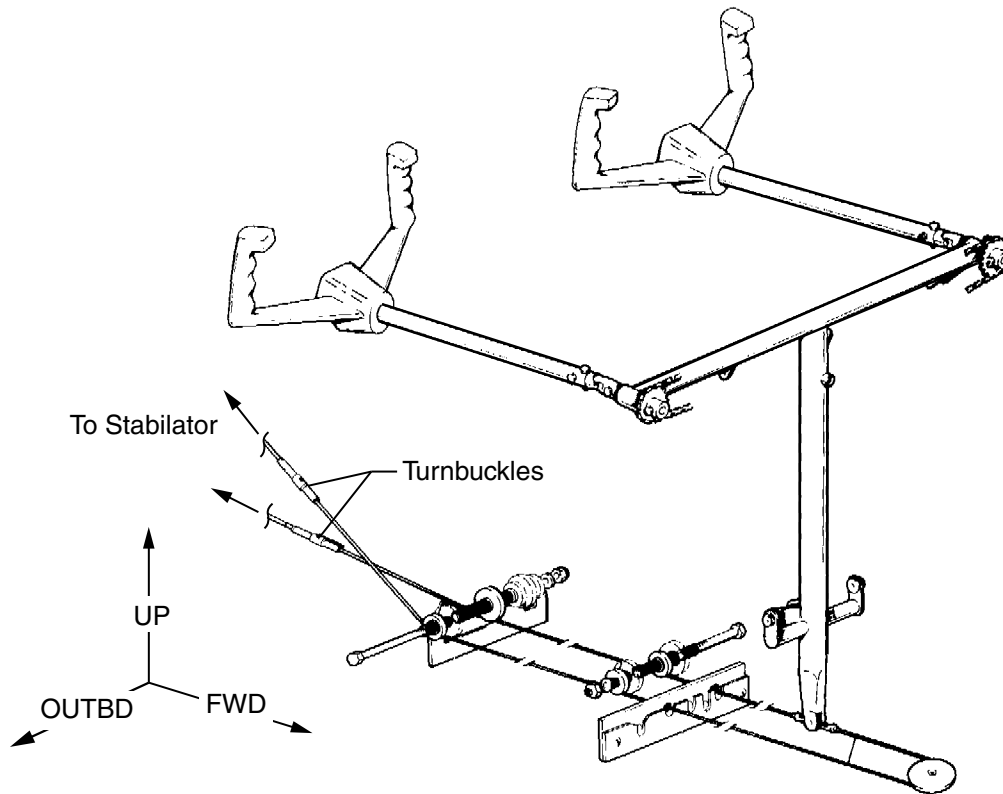
Figure 1
Stabilator Control Cables (Typical)

Existing Instructions for Continued Airworthiness (i.e., the appropriate Piper Maintenance Manual and associated Service Publications) include an inspection of all flight control pulleys, cables, fittings and turnbuckles on a recurring basis. However, service history suggests that over time, the turnbuckles used in the stabilator flight control cable system may develop cracks or corrosion which may not be detected during these inspections.

3. Remove and retain the access cover from the rear cabin bulkhead, in order to gain access to the tailcone area.
4. Identify the two (2) stabilator flight control cable turnbuckles, which are located inside the tailcone, directly aft of the rear cabin bulkhead. See Figure 1. Using procedures described in the appropriate Service/Maintenance Manual, disassemble the turnbuckle bodies to facilitate a complete inspection of the turnbuckle bodies and associated cable terminals.
5. Clean the turnbuckle bodies and associated cable terminals thoroughly with Methyl Ethyl Ketone (MEK) or acetone prior to inspection. The non-threaded surfaces of the turnbuckle body and cable terminals may be cleaned using Scotch-Brite™ General Purpose Green Scouring Pad 96 or 105b.

6. Using a 10X magnifier, a mirror and a suitable light source, carefully examine the entire surface of each turnbuckle, cable terminal, and adjacent portion of the flight control cable, inspecting for cracks, corrosion, or broken cable strands. Any evidence of cracks or cable fraying, however minute, is cause for replacement. Any evidence of corrosion that remains after accomplishing the cleaning instructions above is cause for replacement.
