AERO ACCESSORIES, INC. SERVICE BULLETIN

SERVICE BULLETIN: SB-008

SUBJECT: Rear Port Wear Indicator Instructions.

APPLICABILITY: AA215CC, AA215CC-9, AA216CW, AA3215CC, AA3215CC-9, A3216CW, AA3225CC, AA3225CC-9, AA3226CW & AA3226-45CW.

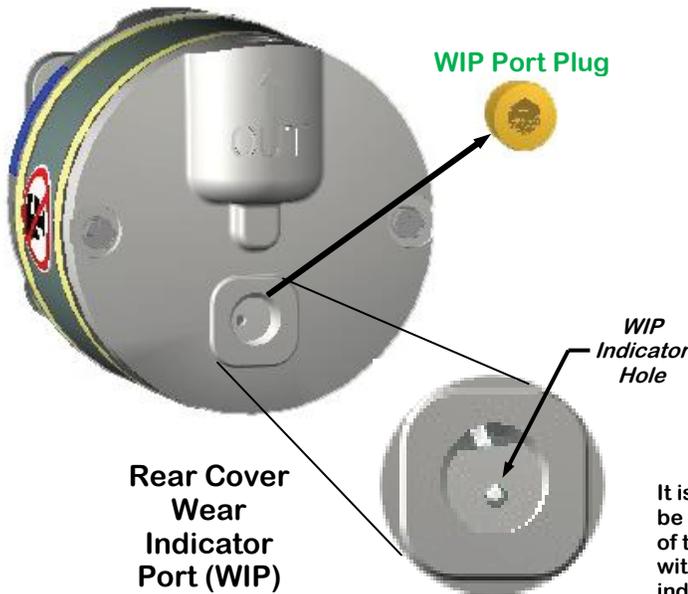
If the 600 hour inspection reveals the inside edge of the vane in the indicator hole, the next inspection should be at 800 hours of pump service, and thereafter every 100 hours.

If the 600 hour inspection reveals the inside edge of the vane at or below halfway of the indicator hole the next inspection should be at 700 hours of pump service, and thereafter every 100 hours.

It is recommended that the pump be replaced when the inboard edge of the vane is observed anywhere within the bottom 1/8th of the indicator hole.
