# Grandpa's Rocker or The Ins and Outs of Articulating Seats

By Dennis Wolter  
*Air Mod*

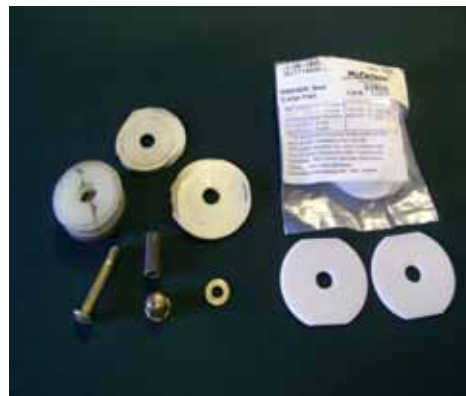
*New McFarlane tefton thrust washers and seat rollers*

While the seat tracking rollers are removed, install new side thrust washers (available from McFarlane Aviation). The originals from

Cessna were made using the same plastic as your lovely window frames and often are totally shot by the time you inspect or upgrade your seats. The side thrust washers are there to reduce side travel and wiggle as the seat sits and tracks on the rails. These washers also prevent metal-to-metal contact between the seat feet and the seat rails, and help to insure proper alignment of the seat latch pins and the seat track holes.

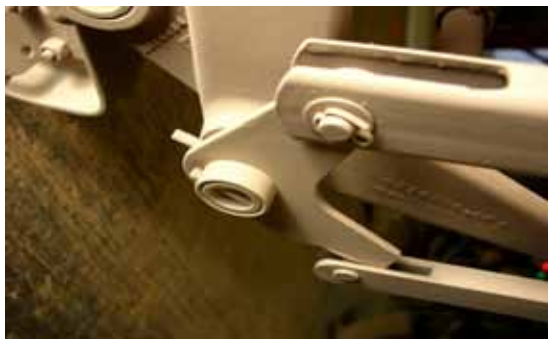
*Loose roll pins halfway out of the seat back reclining bellcrank*

lots of roll pins. Any slippage of these pins must be corrected. The most common place to find loose roll pins will be the pins that secure the seat reclining bell crank to its supporting shaft. These small pins will often work their way halfway out of their holes, causing all of the torsional load (and there is lots of it at this point in the mechanism) to be concentrated on only half of the cam attachment. Inspect the cam for cracks or oversizing of the holes. A crack means a new cam is in order. Due to close tolerances at this cam, oversized holes cannot be reamed to accommodate the next larger diameter roll pin. Again, a new cam is required. If the pins and holes are in good condition in a crack-free cam, reset the roll pin so it is fully supporting both sides of the cam at the shaft, and use .032" safety wire to prevent future slippage.

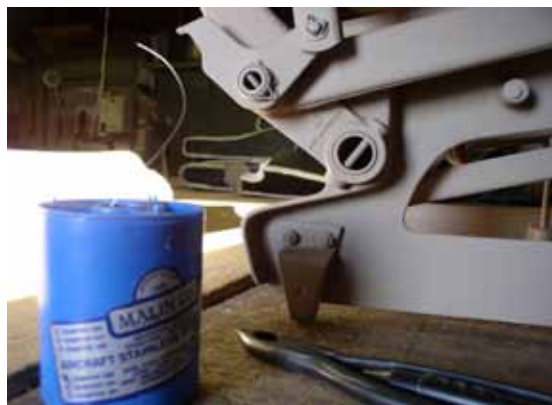
*New roll pins installed and safety wired in the seat back reclining cam*

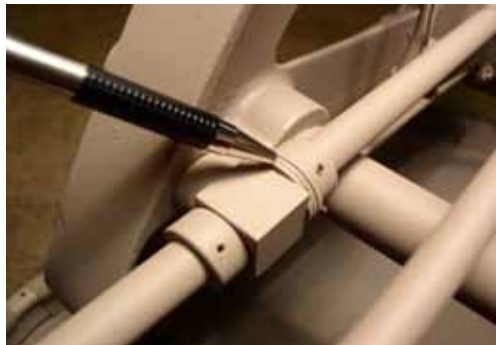
**JACK SCREW WEAR:** The crank operated jack screws, for both height and reclining adjustment, can become worn, resulting in longitudinal play that will allow the seat to rock fore and aft. This looseness can be eliminated by adding additional shim washers to the existing stack of washers adjacent to the chrome crank. You can usually find the needed sized shims from local machine shop supply companies. In a pinch, I will dimension a washer using a belt sander.

*Seat back reclining bellcrank jack screw shims*

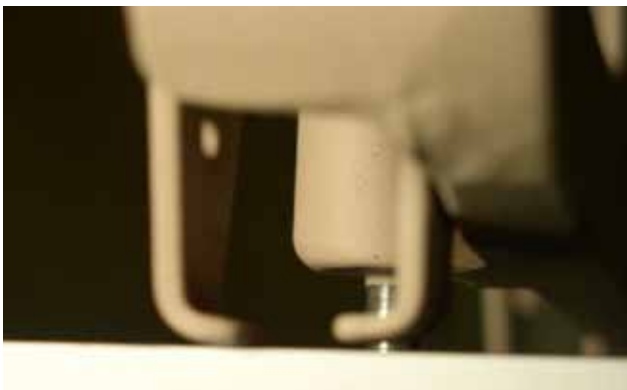
**WORN SEAT ROLLERS & FEET:** Cessna used durlon or aluminum to fabricate their seat rollers. Wear and appreciable wobble in these rollers requires replacement, and don't forget to replace the previously mentioned thrust washers. Cessna recently released service bulletins SEB 11-4 and MEB 11-2, that more fully address long-standing issues surrounding seat track AD 2011-10-09. Of particular note is a new focus on the condition of the seat feet. Two major issues are addressed by this service bulletin, one being the deformation of the foot caused by undue stress, and the second being wear of the points of the foot itself. Follow the dimensional criteria of this service bulletin; both your safety and the amount of wiggle reduction will benefit. Don't forget your seat rails. Even if the holes are good, plenty of rails are worn on the bottom side of the top flange. All this wear adds up.

*Carefully inspect the seat feet per Cessna service bulletin SEB 11-4 and NEB11-2*

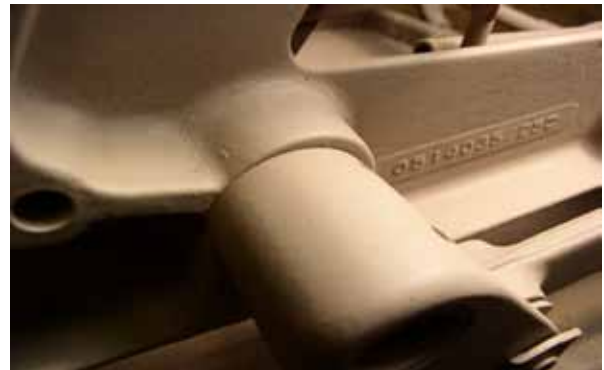
**WORN HEIGHT ADJUSTMENT SHAFT PIVOT POINTS:** I saved the best for last. The least common but most difficult issue to correct is wear in the holes for or in the large diameter pivot tubes. Due to lack of lubrication, considerable wear can develop where these steel shafts pass through the cast aluminum seat frame. Correction of this problem requires in-depth disassembly of the seat. Outside and inside micrometers will identify worn parts. If the shafts are worn, new components will do the job. If the seat frame holes are worn, custom made bushings are in

*Seat height pivot points; definitely oil these at every annual inspection*

order. This level of repair will require a field approval since the seat frame is primary structure. In this case, I would either live with it or look for a used seat in better condition.

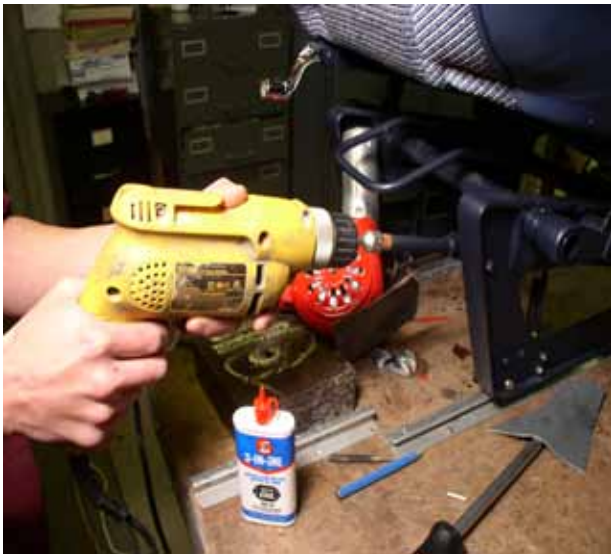
*Drill motor trick to loosen tight seat height adjustment pivot shafts*

Over the years, we've seen a number of articulating seats that present frozen-in-place height adjustment tubes, likely due to lack of use or insufficient lubrication. To correct this, we mix a concoction of 50% ACF50 or CorrosionX and 50% lacquer thinner. A couple of times a day we brush on a generous amount of this penetrating mixture on both sides of the height adjusting tube where it passes through the cast aluminum seat frame. Continue this process for several days. Use a heat gun (no open flames please) to heat the seat frame until it is hot to the touch and then actuate the height adjustment crank in both directions in an attempt to create some movement in the two shafts. Sometimes we will also use a large crescent wrench to break the frozen shafts loose. Repeated applications of penetrant, heat and cranking will eventually do the job (remember, if you lubricate your seats once a year this problem can be avoided). Once we break the height adjustment pivots loose, we remove the handle of the jack screw and then use a nut driver with a slot cut in it to run the seat up and down until the seat height adjustments function smoothly.
