McFarlane Aviation Products

How McFarlane Cables are Swaged and Why it Matters

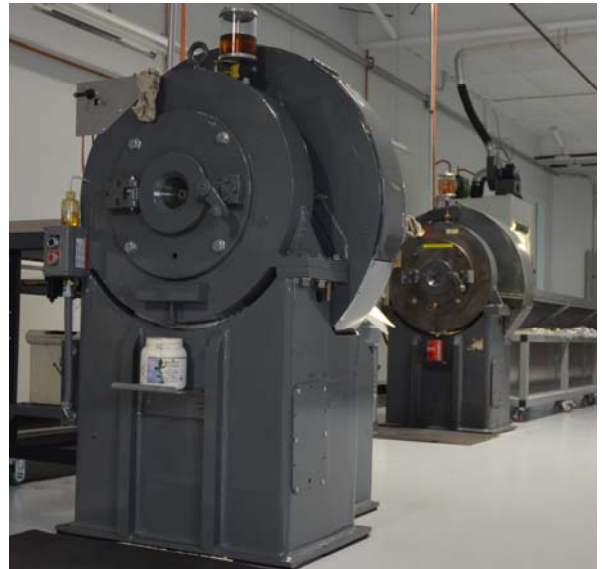
Based on this knowledge, we long ago invested heavily in industrial rotary swaging machines that do not have this problem even though the cheaper air swagers are still allowed by the military specifications that dictate the manufacturing methods for aircraft cable assemblies. Although the use of rotary swagers as opposed to air hammers does not totally preclude the possibility of a cable terminal failing due to stress corrosion cracking, we feel it does make our cables significantly safer than those manufactured with alternative methods.
